Landmark Home Inspections

Property Inspection Report

(Property Address), CO

Date of Inspection: 3/21/2019

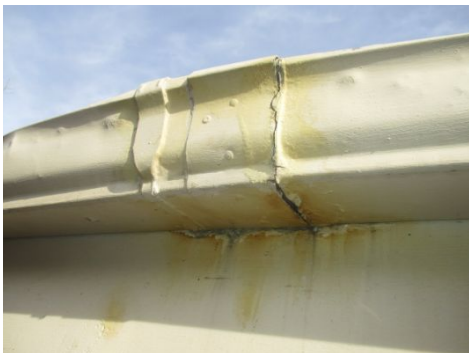
- Repair: Observed multiple areas where the gutters above the back patio area were damaged and showed signs of previously leaking. Recommend repair by a qualified contractor.
- Repair: The gutters require cleaning to avoid spilling roof runoff around the building - a potential source of water entry or water damage.

Evidence of previous leaking

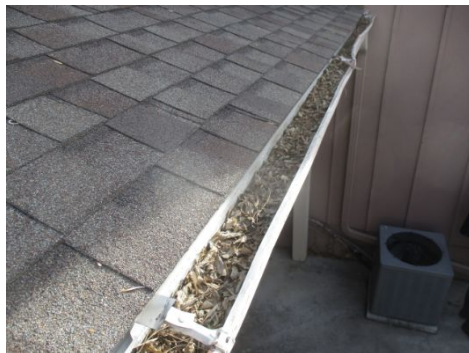
Gutters require cleaning

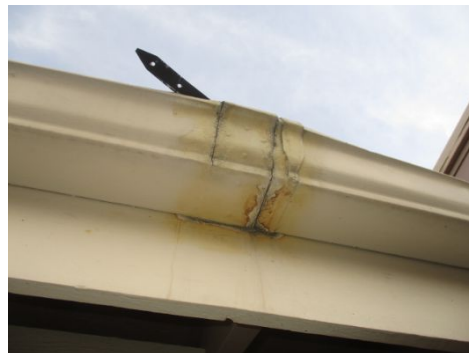
Evidence of previous leaking

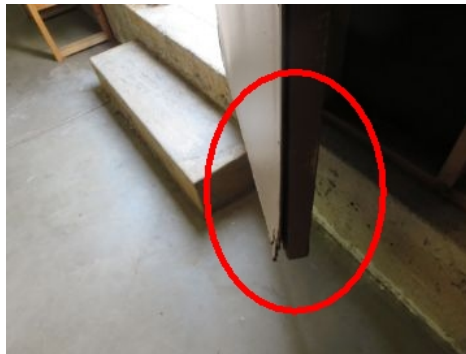
- Repair: Noted minor damage to the main door to the garage. Repair as necessary.

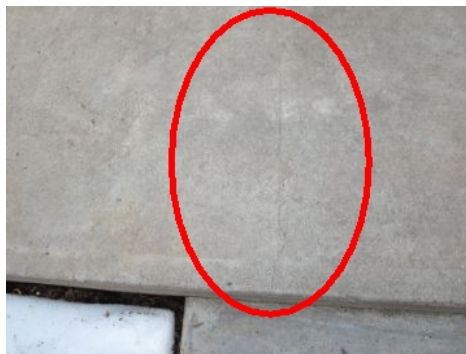
- Repair: Observed multiple areas of minor cracking and damage at the front porch and front entry walkway. Repair as necessary.

Curing fissure along front porch

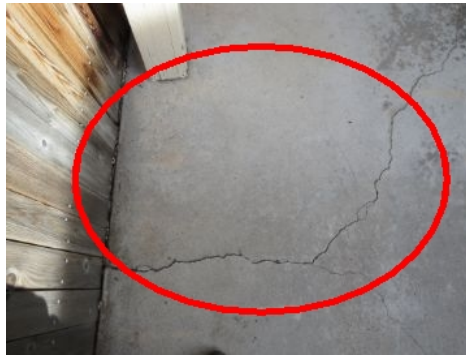
- Monitor: Observed minor cracking and spalling at the back patio slab. Repair/replace as necessary.

Settlement cracks

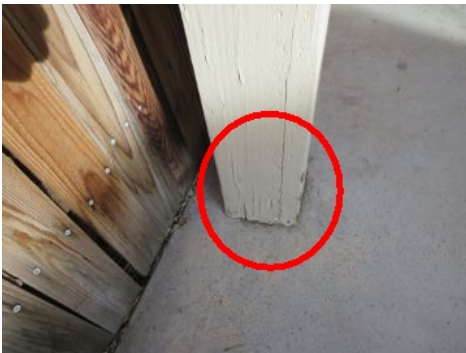
- Repair: Observed multiple areas of unprotected wood siding/trim. Unprotected wood should be painted to preserve the life of the construction.
- Repair: Observed minor wood rot on the exterior of the home. Recommend repair by a qualified contractor.

Peeling paint along rear deck support

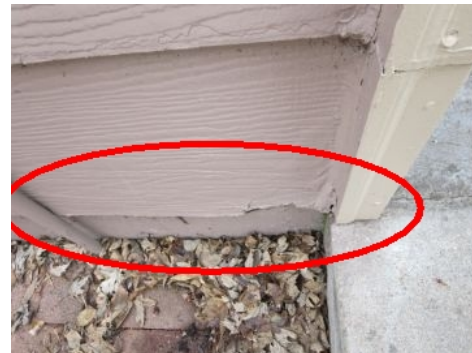
Minor wood rot along garage siding

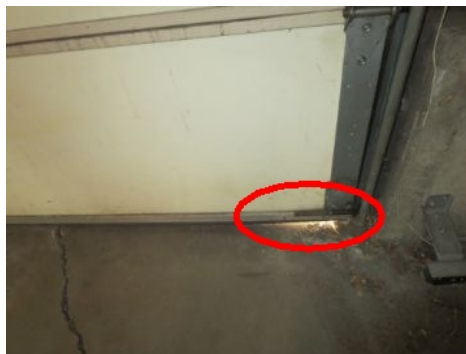
- Repair: Recommend adjusting gap in weatherstripping along the garage door to reduce the risk of potential pest and moisture intrusion.

Gap beneath garage door weatherstripping

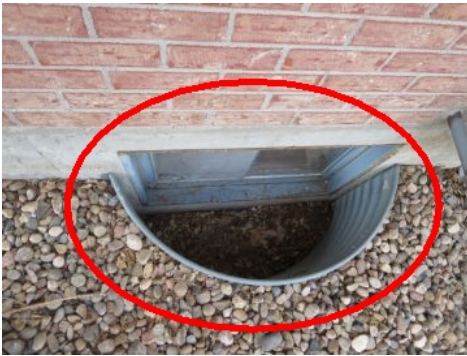
- Repair: Window well covers should be added to prevent debris collection and water entry into the home.

Missing window well covers

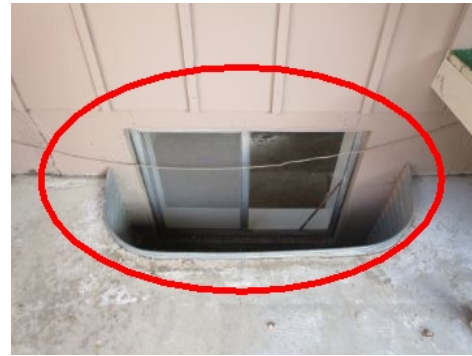
Missing window well cover

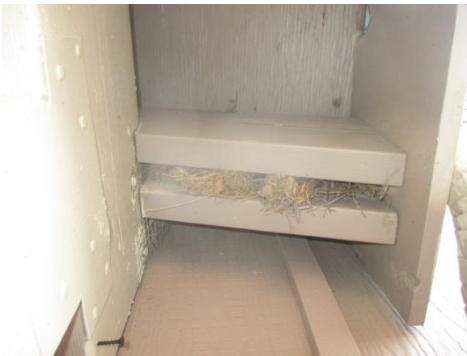
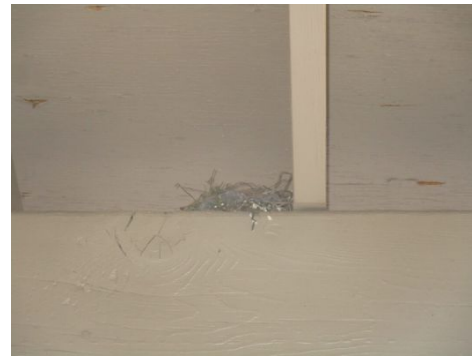
- Repair: Birds nests should be removed from the home.

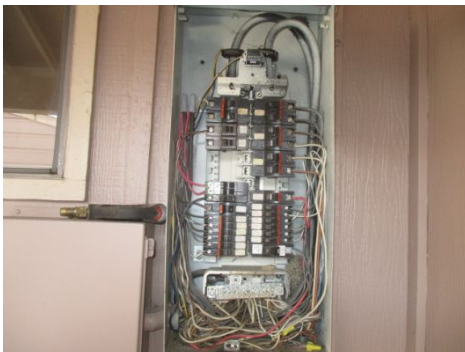
- Safety Issue: The main electrical panel is a Stab-Lok manufactured by Federal Pacific. These boxes are no longer in production because of a high rate of defective breakers which lead to a higher risk of electrical fire. Recommend that a licensed electrician evaluate before closing.
- Safety Issue: The main electric panel cover did not correctly latch/secure with a screw. Recommend that a licensed electrician evaluate for necessary repairs.
- Repair: Observed wire crowding at the electric panel. Recommend repair by a licensed electrician.

Stab-Lok panel

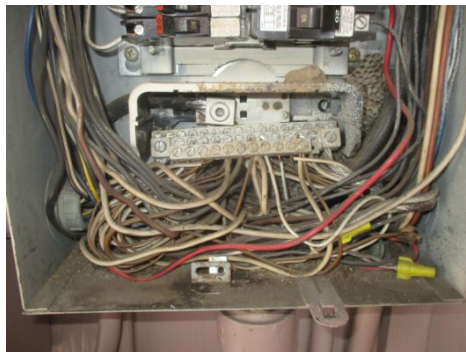
Wire crowding

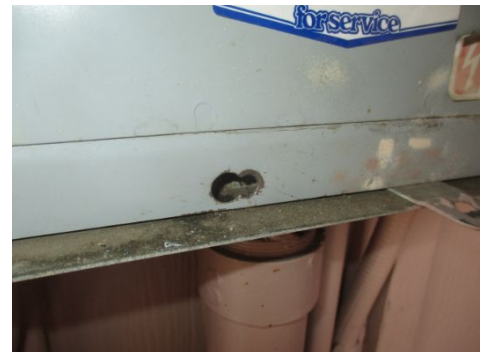
Panel cover screw could not be secured

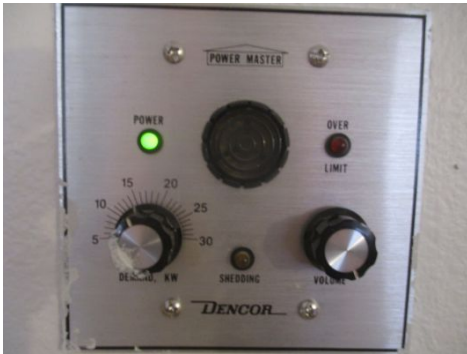
- Monitor: Observed a Dencor control panel and junction box. The junction box was tapped to the main terminals of the main distribution panel. Was unable to determine the function of this system. Recommend evaluation by a licensed electrician.

Control panel in living room

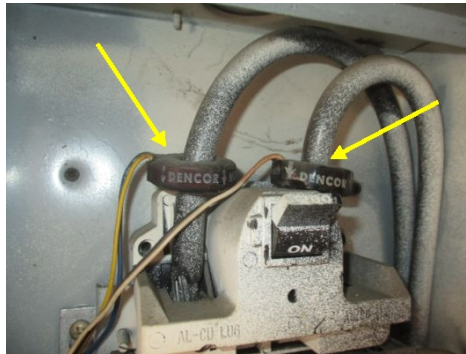
Junction box tapped into main terminals

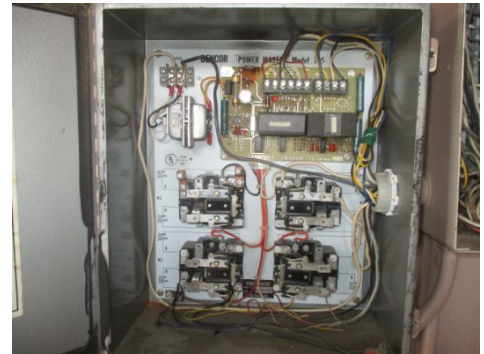
Dencor junction box

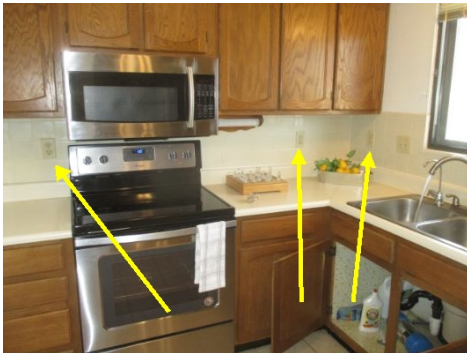
- Repair: The installation of ground fault circuit interrupter (**GFCI**) devices is recommended on exterior, garage, basement, bathroom, some kitchen outlets, and any outlet within 6' of water. Recommend that a licensed electrician evaluate for necessary repairs.
- Monitor: No power was detected at the basement laundry dryer outlet. Recommend evaluation by a licensed electrician.
- Repair: The installation of ground fault circuit interrupter (GFCI) devices should be installed at any outlet within 6' of a water fixture.

GFCI protection needed in kitchen

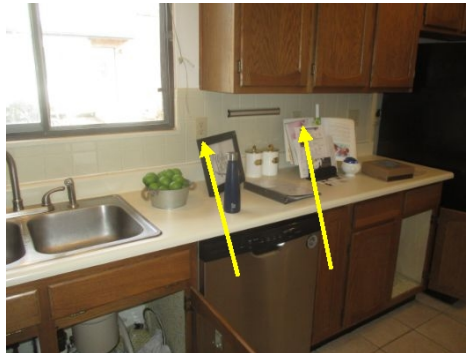
GFCI protection needed in kitchen

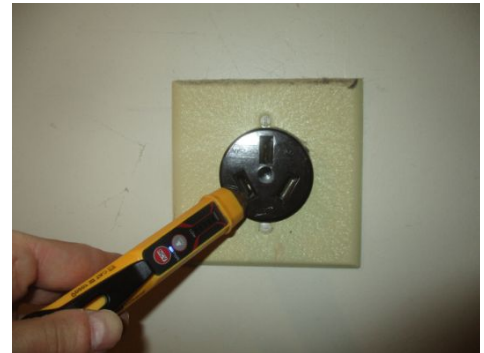
No power detected at basement laundry outlet

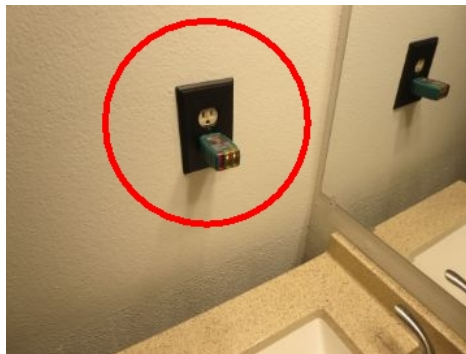
No GFCI outlets located in bathrooms or garage

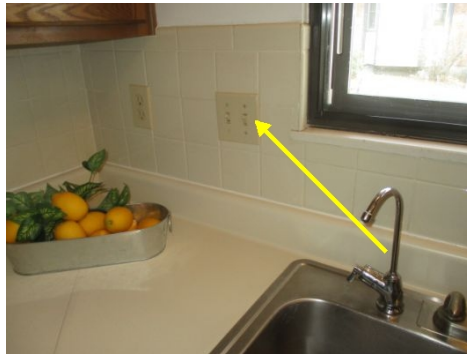
- Repair: The switch designated for the garbage disposal functioned with a reverse function. The "On" function operates when the switch is pointed downward. Repair as necessary.

Reverse function at this kitchen sink switch

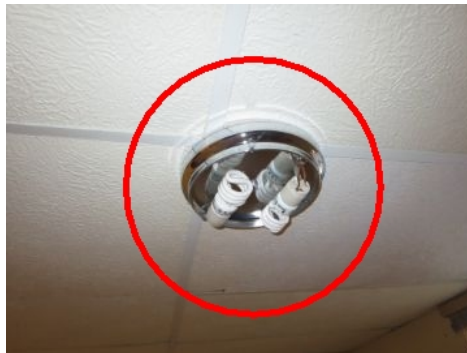
- Safety Issue: Observed a missing light fixture cover at the time of inspection. Recommend installing cover.

Missing light fixture in basement

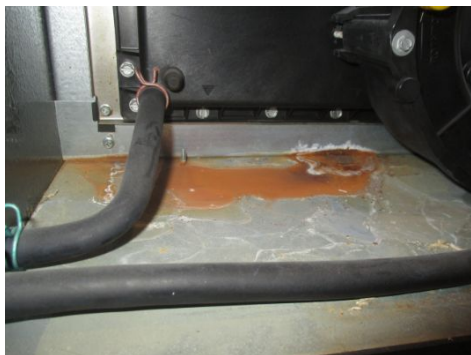
- Repair: Observed rusting within the furnace burner cabinet. Recommend that a licensed HVAC technician evaluate before closing.
- Repair: The furnace filter was not securely installed at the time of inspection. The filter did not appear to have a designated slot and was placed loosely at the return duct entry. Recommend that a licensed HVAC technician evaluate for necessary repairs.
- Repair: Orange flames were observed at the furnace burners. Narrow blue flames are typically associated with healthy furnace function. Recommend that licensed HVAC technician evaluate for necessary repairs before closing.
- Monitor: The home's HVAC system drains condensation into an electronic pump. This pump will need to be operational to correctly drain the system of condensation. Monitor this pump for correct function and repair if necessary.

Rusting

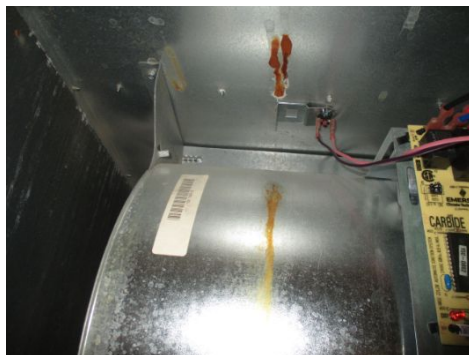
Rusting

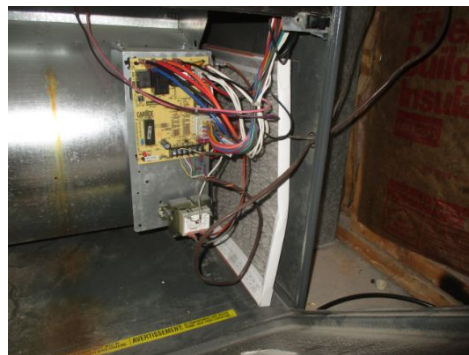
Filter loosely installed

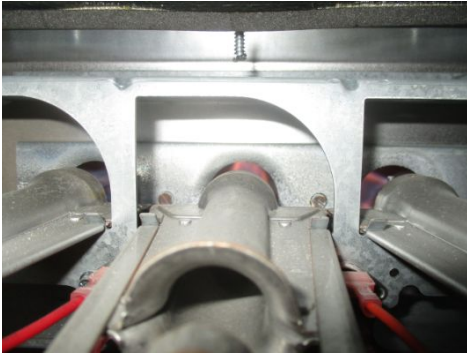
Orange burner flame color

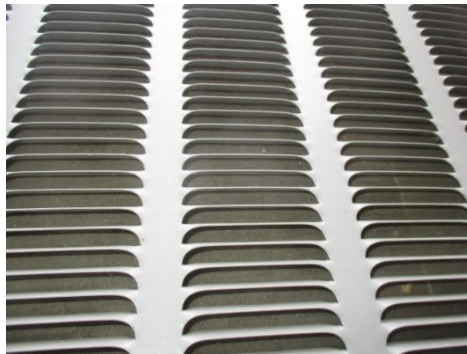
- Repair: The condenser fins were dirty at the time of inspection. Recommend repair by a licensed HVAC technician.
- Monitor: No service records were observed for the air conditioning unit. Recommend full service and evaluation by a licensed HVAC technician before closing, if not done so in the last 12 months.

Dirty condenser fins

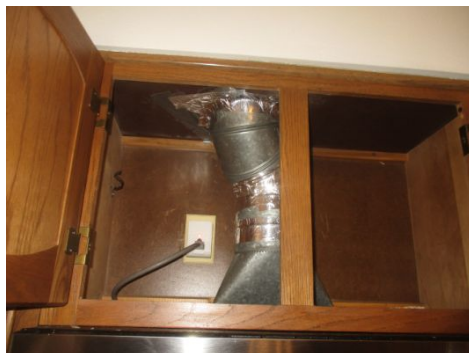
- Repair: Was unable to locate an exhaust point for the microwave exhaust fan. This fan should vent to the exterior of the home. Recommend that a qualified contractor evaluate for necessary repairs. before use.

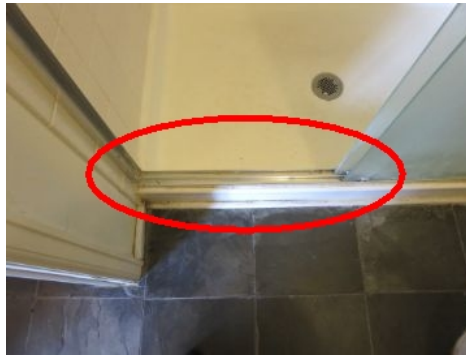
• Repair: Recommend sealing all gaps along the shower stalls to reduce the risk of potential moisture intrusion.

Seal gaps along the master shower

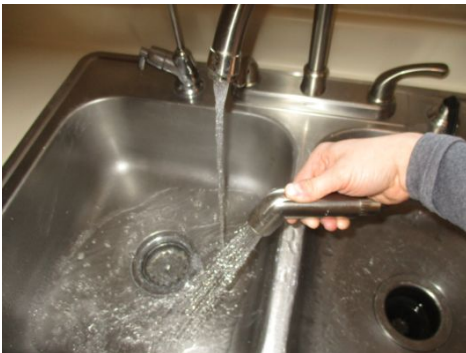
- Repair: The kitchen sink sprayer appeared to have a defective diverter valve, as it fails to correctly divert all water from the faucet to the sprayer. Repair as necessary.
- Repair: Observed a slow drain at the basement laundry sink. Recommend repair by a licensed plumber.

Defective diverter valve

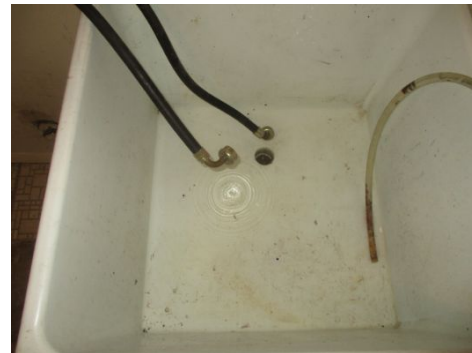
Slow drain at basement laundry sink

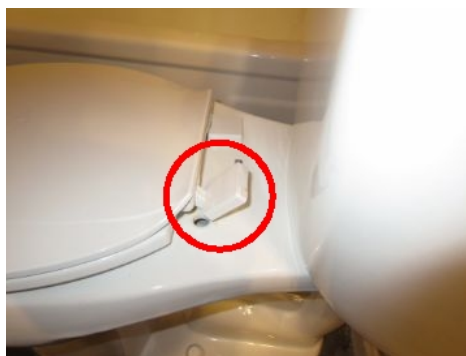
- Repair: Toilet seat in 2nd floor bathroom is damaged at th time of inspection. Recommend replacement.

Damaged toilet lid bracket in 2nd floor bathroom

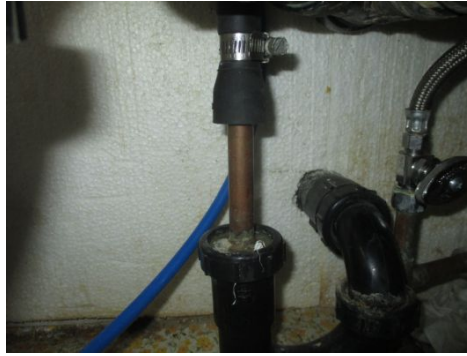
- Monitor: The dishwasher drained into a flexible drain line which fed to a small copper pipe attached to a plastic drain pipe. The dishwasher drained correctly at the time of inspection and no evidence of previous leaking was observed. Monitor for correct function and repair as necessary.

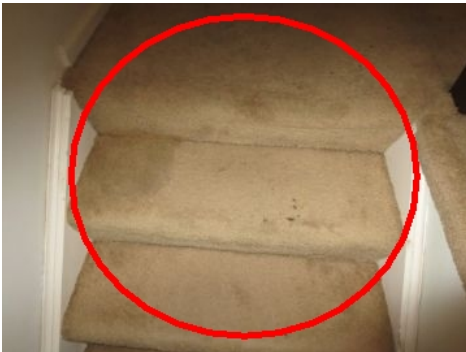
- Repair: Observed multiple areas of damaged/stained flooring within home. Recommend that damage flooring be repaired/replaced.

Multiple stains throughout carpeting

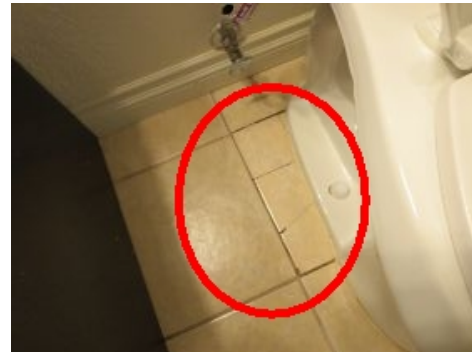
Cracked tiles along the 1st floor half bathroom

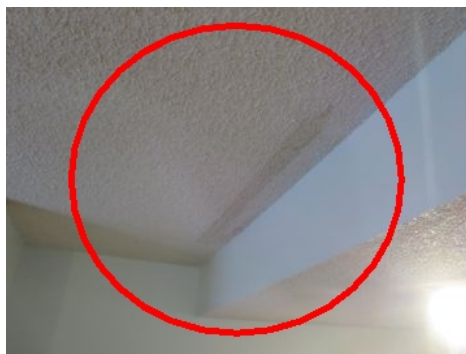
- Monitor: Observed multiple moisture stains within the home. Was unable to determine the source of these stains. These areas were dry at the time of inspection. Confer with owner about source of these stains. Monitor and repair as necessary.

Apparent moisture staining above the living room

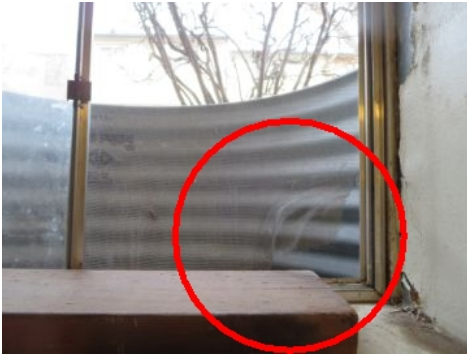
- Repair: Noted torn screen(s) in the home at the time of inspection. Recommend repair/replace as needed time of closing.
- Repair: Observed a window within the master bedroom that had an apparent broken seal, allowing the insulating gas to escape. It is possible that other windows may have lost their seal but did not have visual symptoms at the time of inspection. Recommend repair/replacement of defective glass, and having a window specialist evaluate all windows in home for similar defects.

Torn screen in basement window

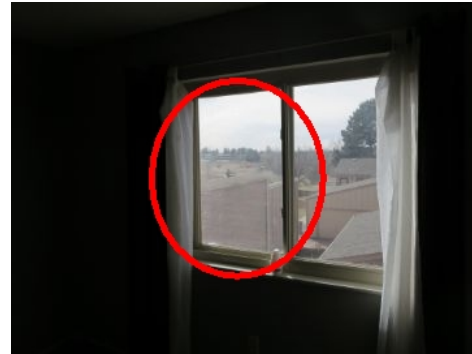
Broken seal in master bedroom window

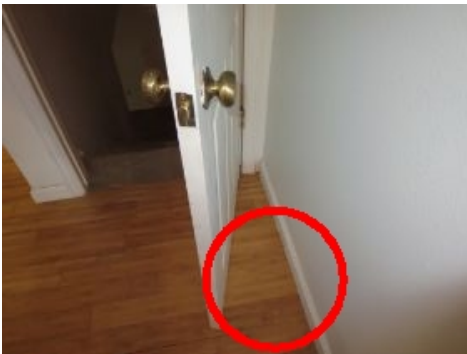
- Repair: All door should have stops to prevent damage to wall or other interior house components. Repair as necessary.
- Repair: Observed multiple damaged door knobs at the time of inspection. Repair as necessary.

Missing door stoppers throughout home

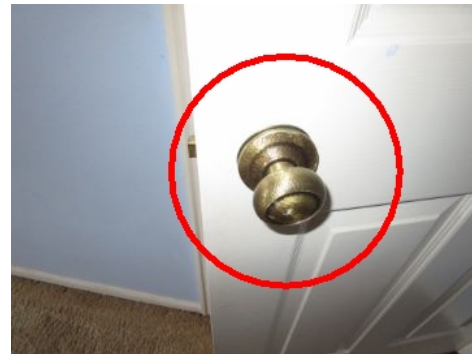
Multiple loose/damaged door knobs observed

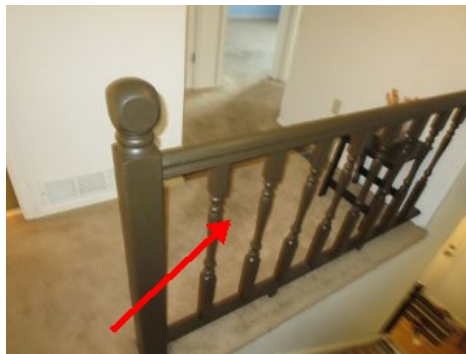
- Safety Issue: Handrail balusters should be spaced no more than 4" apart. Recommend repair.

Improperly spaced balusters on 2nd floor

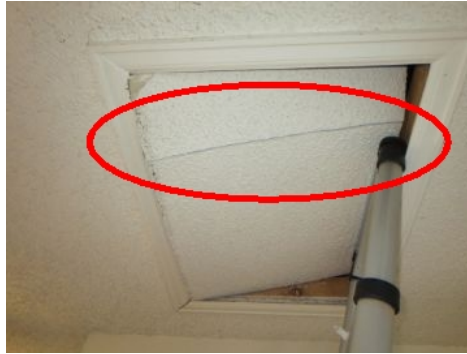
- Repair: The attic hatch was broken at the time of inspection. Repair as necessary.

Damaged scuttle hatch

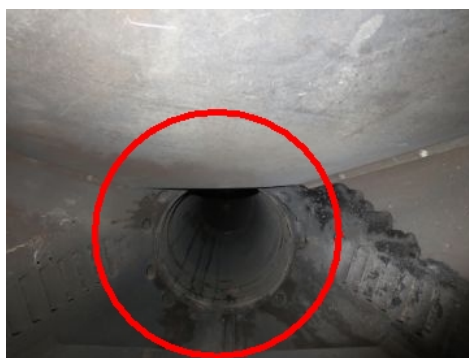
- Repair: The fireplace was not operational at the time of inspection. It appeared that the pilot had not been lit. The fireplace should be tested for correct operation before closing.
- Repair: The fireplace chimney appeared to be missing it's damper. Recommend repair by a licensed chimney technician.

Missing damper in fireplace
